ISLAND VIEW 4

QUAY SIDE INSPECTION

13 AUGUST 2018
DURBAN
SOUTH AFRICA

Island View 4
Quay Side Pile Inspection
13 August 2018 – 15 August 2018
SSD18-001B-032
Katlantic

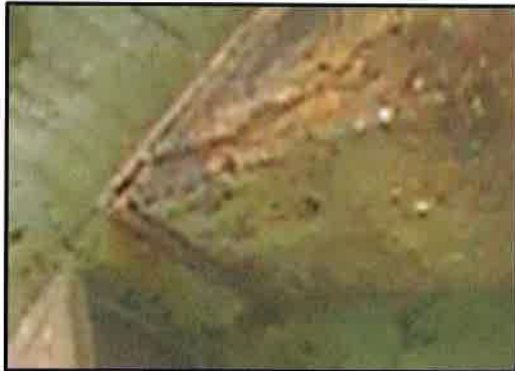
Allocation	Pile	Spine beam default	Slab underbelly default	Pile default	Pile default Depth	Comment	Marine growth coverage	Type of fouling
A	0	No anomalies noted	No anomalies noted	No anomalies noted	N/A	General over view in good condition	90 -100%	Soft and hard marine growth
A	1	Surface crack, minor/cosmetic	No anomalies noted	No anomalies noted	N/A	General over view in good condition	90 -100%	Soft and hard marine growth
A	2	No anomalies noted	No anomalies noted	No anomalies noted	N/A	General over view in good condition	90 -100%	Soft and hard marine growth
A	3	No anomalies noted	No anomalies noted	No anomalies noted	N/A	General over view in good condition	90 -100%	Soft and hard marine growth
A	4	No anomalies noted	No anomalies noted	No anomalies noted	N/A	General over view in good condition	90 -100%	Soft and hard marine growth
A	5	No anomalies noted	No anomalies noted	No anomalies noted	N/A	General over view in good condition	90 -100%	Soft and hard marine growth

A - Line Crack line Spine beam.

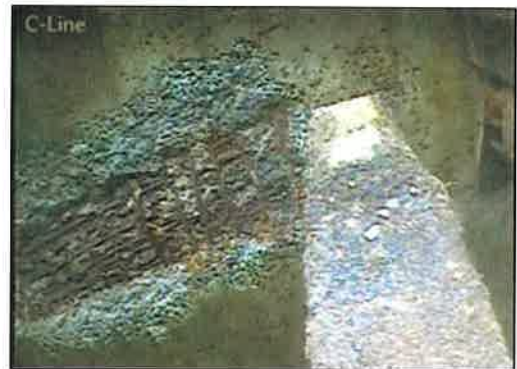
C - Line Detachment

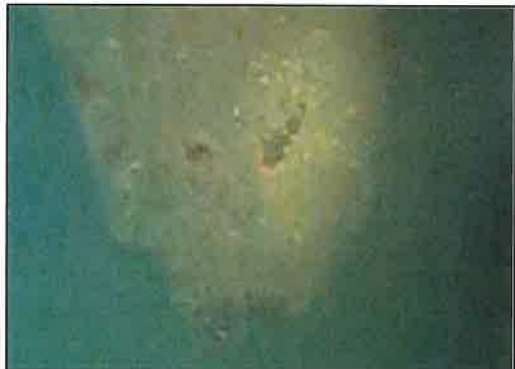
C - Line, base no infrastructure

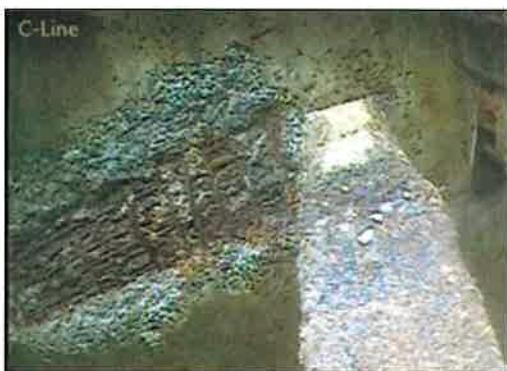
C	23.1	No anomalies noted	Minor honey combing/delamination	No infrastructure	No infrastructure top of pile - No infrastructure base of pile	90 -100%	Soft and hard marine growth
C	23.2	No anomalies noted	Minor honey combing/delamination	Minor delamination	General over view in good condition	90 -100%	Soft and hard marine growth
C	23.3	No anomalies noted	Minor honey combing/delamination	Minor delamination	Possible replacement pile	90 -100%	Soft and hard marine growth
C	24.1	No anomalies noted	No anomalies noted	Minor delamination	General over view in good condition	90 -100%	Soft and hard marine growth

C - Line slab and pile delamination. Group 23

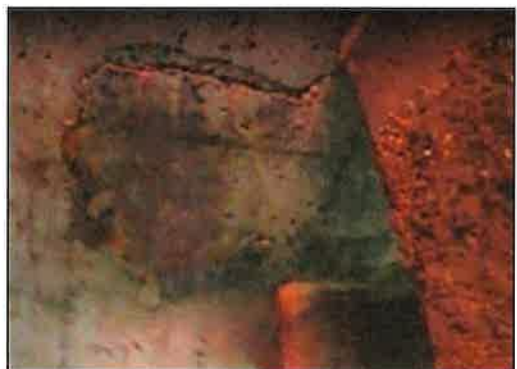
B	4.1	No anomalies noted	Minor delamination and honey combing	No anomalies noted	N/A	General over view in good condition	90 -100%	Soft and hard marine growth
B	3.3	No anomalies noted	No anomalies noted	No anomalies noted	N/A	General over view in good condition	90 -100%	
B	3.2	No anomalies noted	No anomalies noted	No anomalies noted	N/A	General over view in good condition	90 -100%	
B	3.1	No anomalies noted	Honey combing	No anomalies noted	N/A	General over view in good condition	90 -100%	
B	2.3	No anomalies noted	Honey combing	No anomalies noted	N/A	General over view in good condition	90 -100%	Soft and hard marine growth
B	2.2	No anomalies noted	Honey combing	No anomalies noted	N/A	General over view in good condition	90 -100%	Soft and hard marine growth
B	2.1	No anomalies noted	Honey combing	No anomalies noted	N/A	General over view in good condition	90 -100%	Soft and hard marine growth
			Delamination between B3 and B1			Approximately 1.5m ² m surrounding area

Delamination/Honeycombing B3 - B1

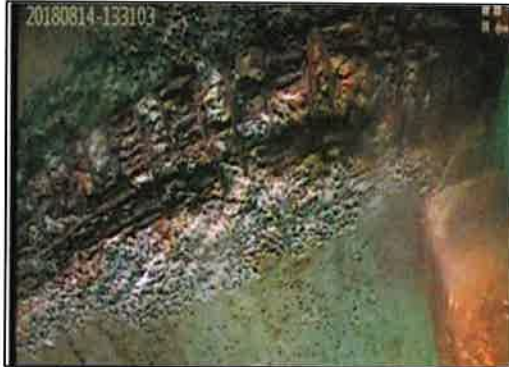
Delamination between B line and C line			Approximately 6m ² m surrounding area		
B	1.3	No anomalies noted	No anomalies noted	No anomalies noted	N/A	General over view in good condition	90 -100%	Soft and hard marine growth
B	1.2	No anomalies noted	Honey combing/Delamination	No anomalies noted	N/A	Delamination between B and C, 4 - 2M	90 -100%	Soft and hard marine growth
B	1.1	No anomalies noted	No anomalies noted	Delamination	4m	545mmx65mm North - 650mmx85mm West	90 -100%	Soft and hard marine growth
B	0.1	No anomalies noted	Honey combing	Cap Impact damage	N/A	650mm Length x 80mm Depth South - 740mm Length x 115mm Depth North	90 -100%	Soft and hard marine growth

Delamination B – C 6mx2m

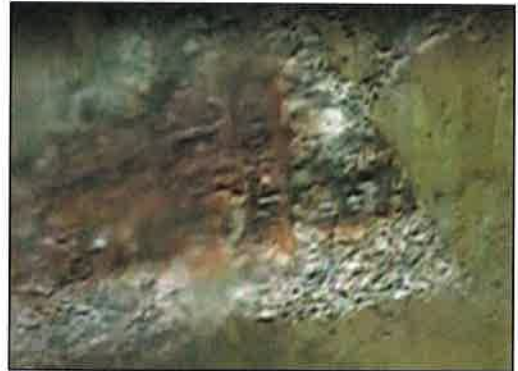
Delamination B – C Group 2

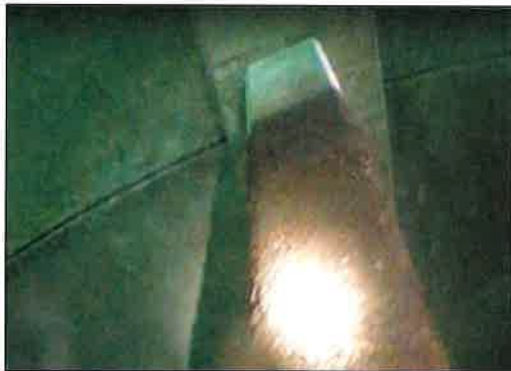
Slab and Pile general overview

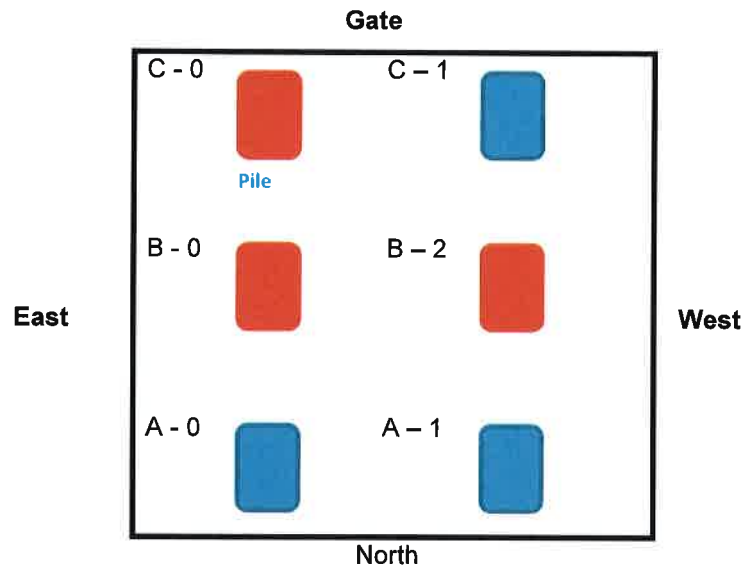
Pile core sample allocation – East end.

C-0.Sample taken at tidal
B-0.Sample taken at 5m depth in water
B-2.Sample taken at tidal

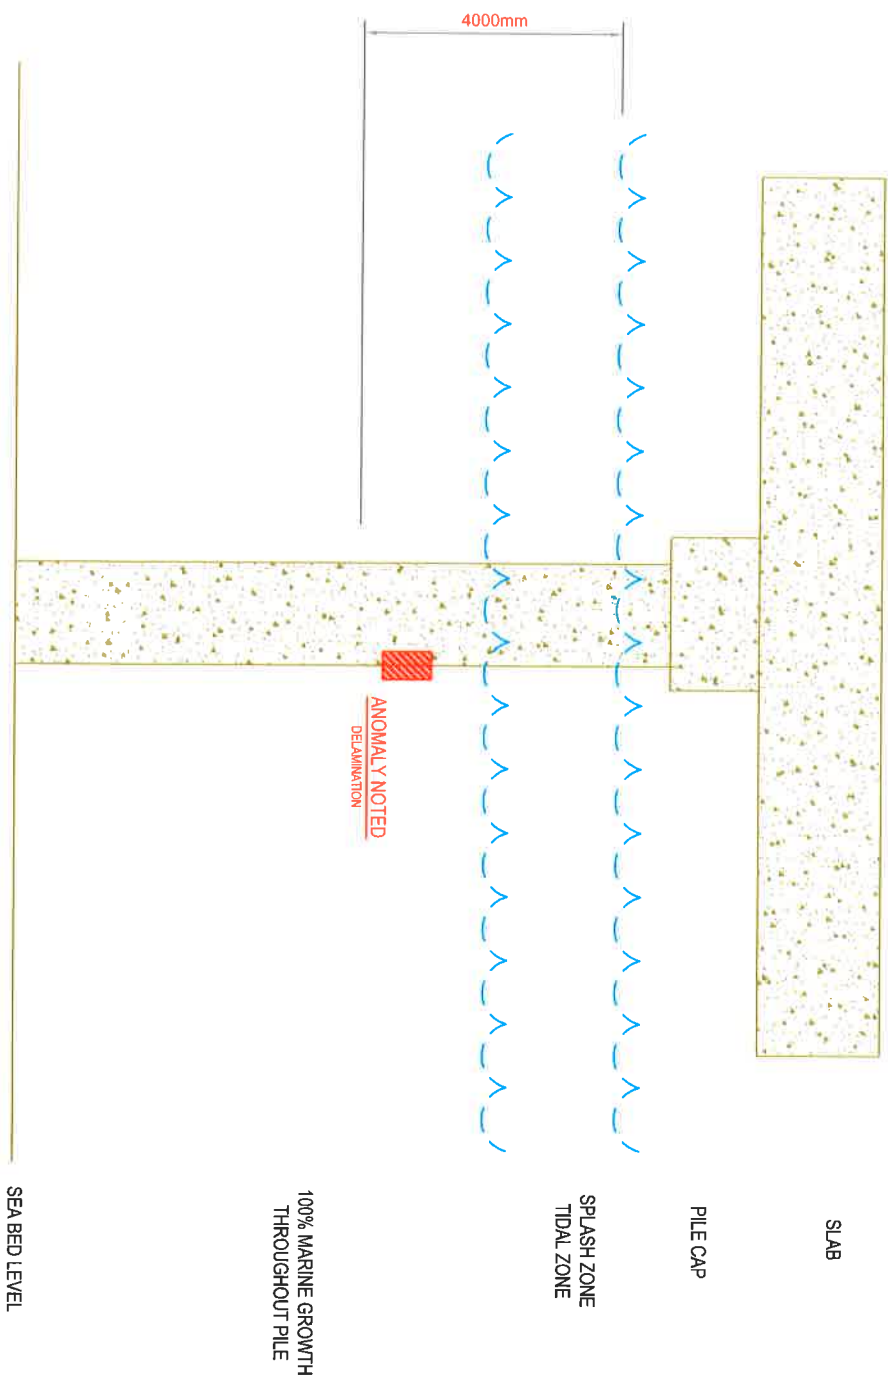
ISLAND VIEW 4
QUAY SIDE INSPECTION
FACING NORTH SIDE
PILE B1.1

100% MARINE GROWTH
THROUGHOUT PILE
