CONTRACT NO.: TNPA 722

PROFESSIONAL SERVICES TO UNDERTAKE THE INSPECTION OF BERTH
4 OF ISLAND VIEW FOR THE PORT OF DURBAN

ENGINEERING REVIEW REPORT

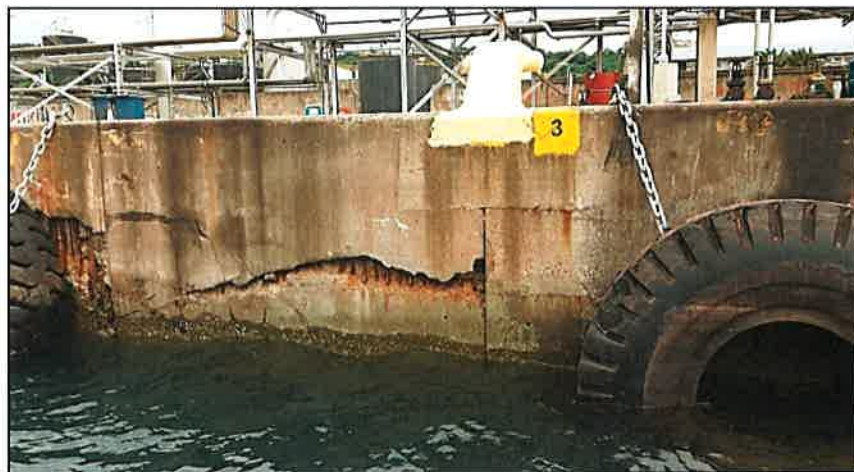
Figure 1: Spalling of concrete on quay wall

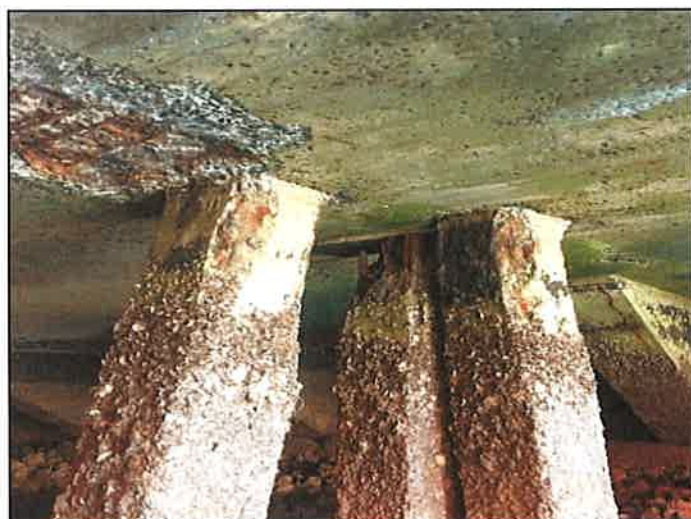
Figure 2: Underdeck concrete spalling

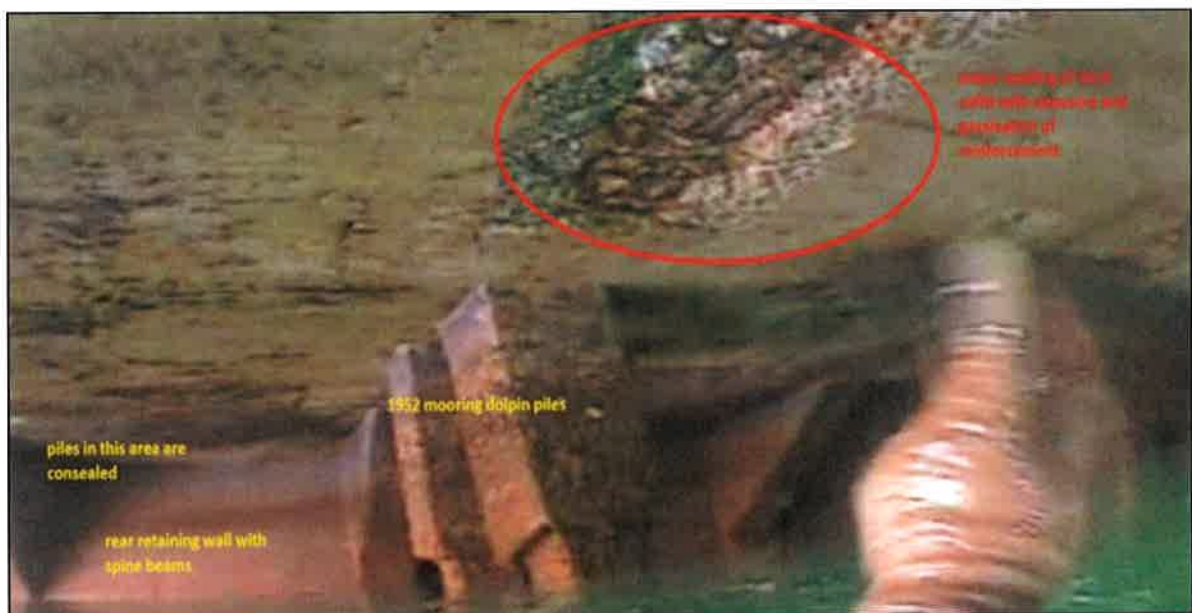
Based on Condition Index for all underdeck deterioration a CI of 40 to 54 is given for Zone 2 i.e. Fair: Moderate deterioration. Function is still adequate. Severity levels of corrosion of reinforcement is 5 where loss of section >20% was noted. Spalling of concrete has a severity level of 3 with spalling 1/3d to 1/2d in depth, where d is concrete cover.

Figure 26: Typical spalling below soffit of old section (1952). Major spalling of concrete and depassivation of reinforcement

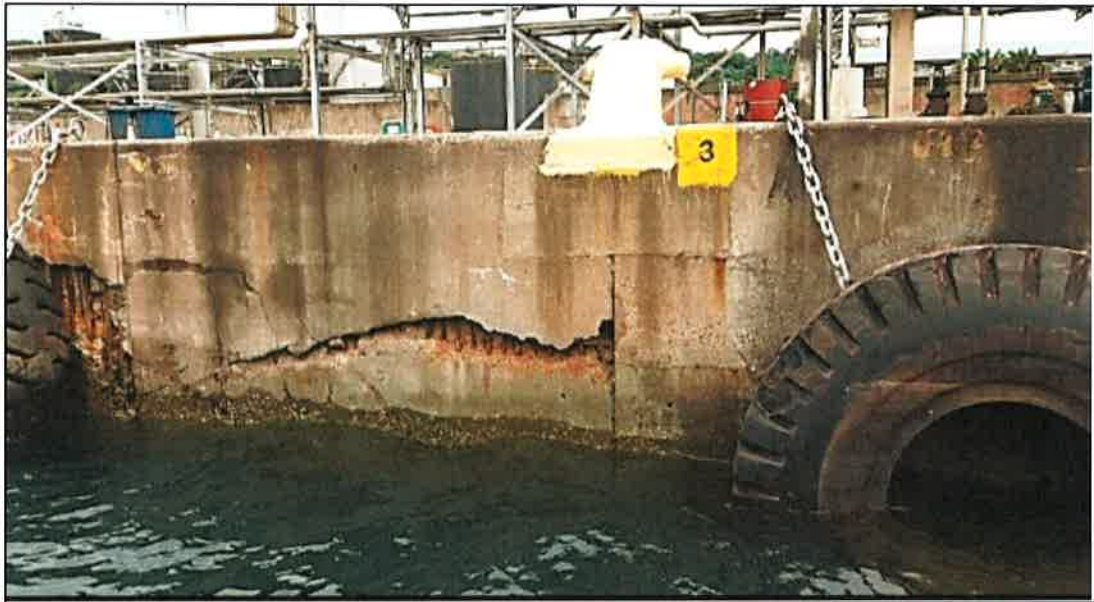
Two precast concrete Quay walls were damaged due to impact load from berthing forces of a 1000 Ton ship. There is extensive exposure of reinforcement and concrete damage as shown in figure 28 below.

Figure 28: Impact damage on Quay Wall

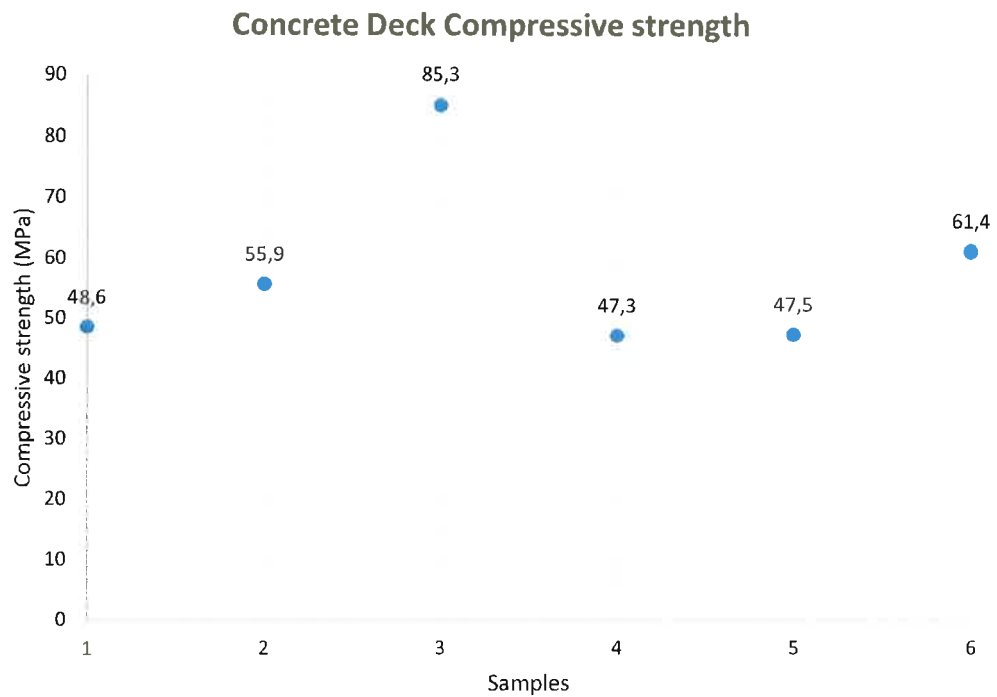
Figure 30: Graph of core sample compressive strength

The mean value for the compressive strength is 62.525 MPa. The standard deviation is 16.22 MPa. The concrete cube strength at 28 days for the concrete deck was 40 MPa. The results are higher than the specified strength for the concrete deck and is acceptable.

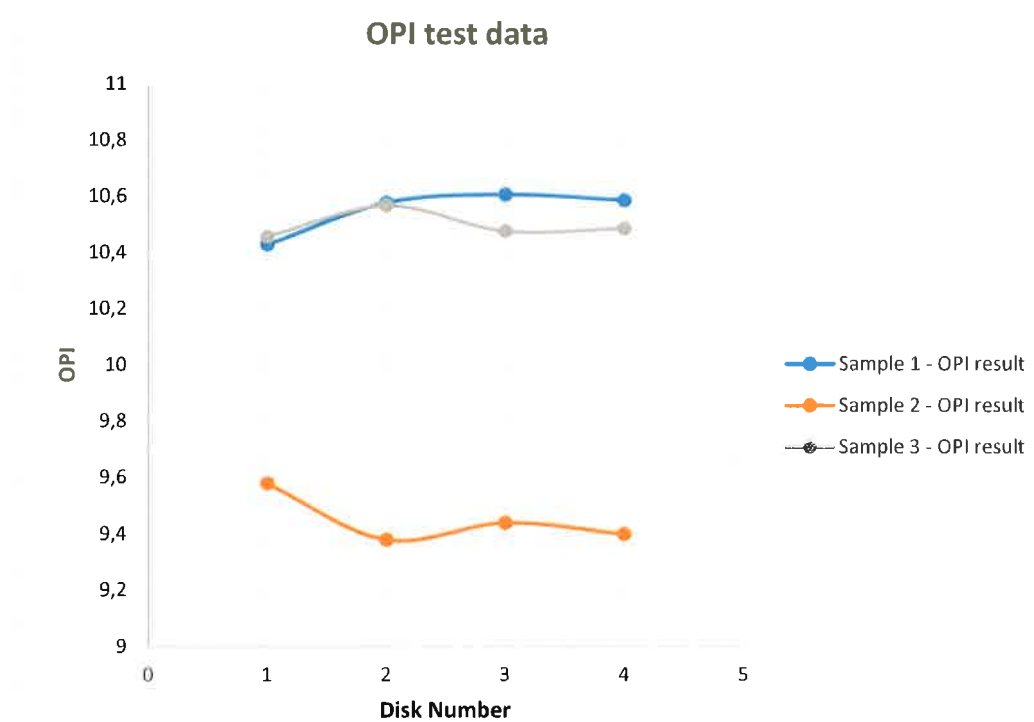
Figure 32: Graph of OPI results

Based on the Plot of the OPI values that were plotted on a log scale from the laboratory results on the Cores from the piles and deck, all core specimens tested fall within the accepted range >9.4 in figure 33. The minimum value is 9.38 which is the Conditional Acceptance range of 9.0 to 9.4. A maximum value of 10.61 was attained. This OPI value is greater than 9.4 and a full acceptance criterion of this range is given as in figure 33 below.

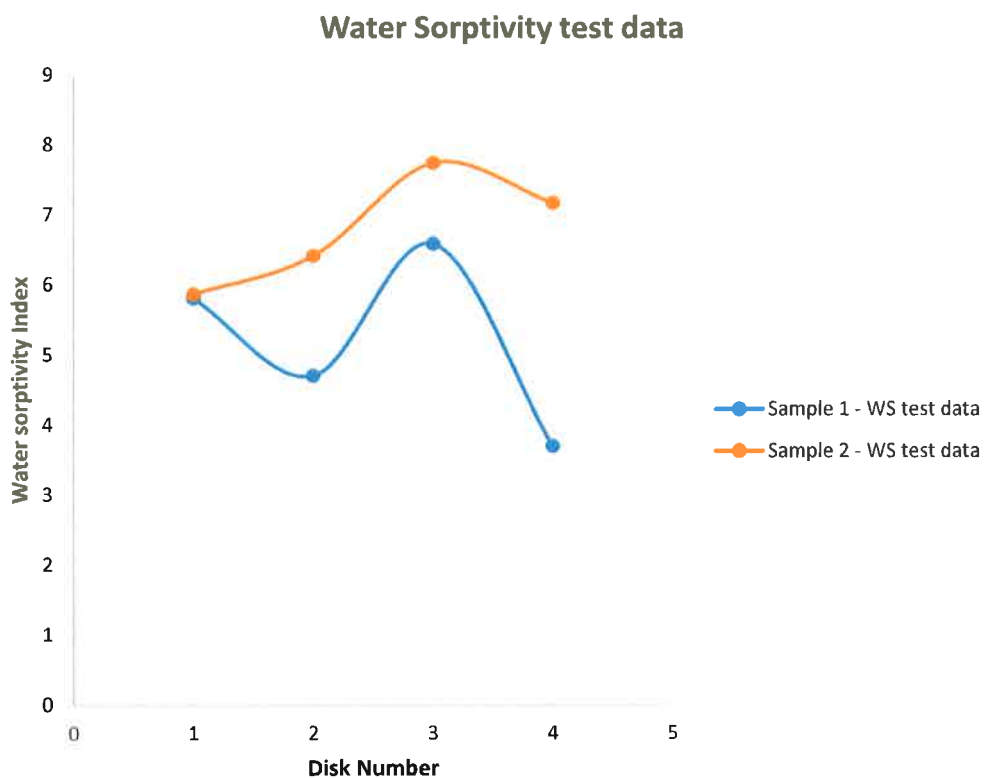
Figure 34: Graph of Water Sorptivity results

Based on the Plot of the Water sorptivity values that were plotted on a log scale from the laboratory results on the cores from the piles and deck, all core

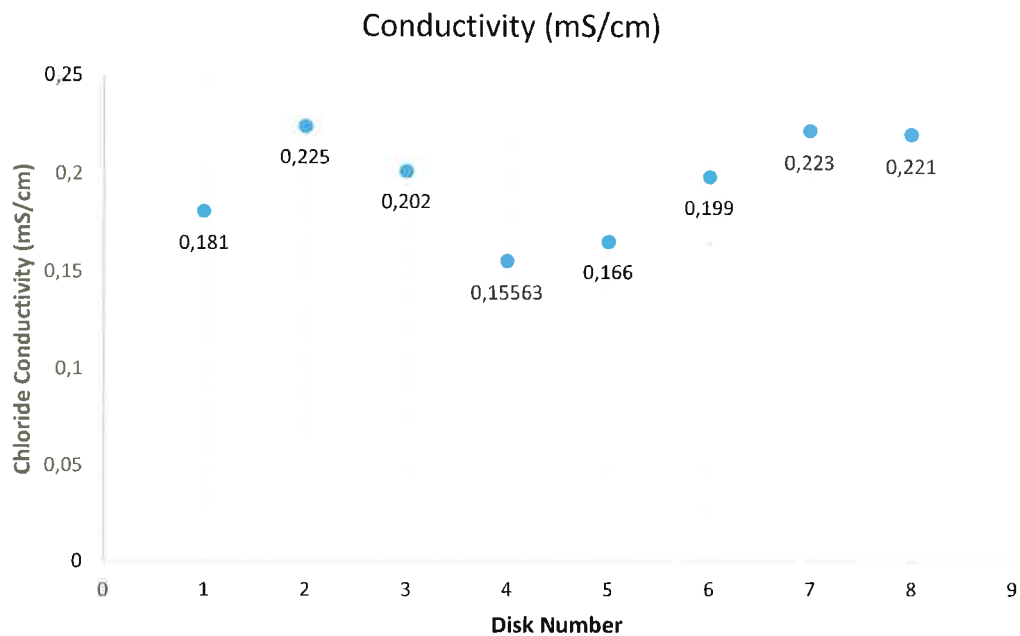
Figure 36: Graph of Chloride Conductivity results

Based on the graphical Plot of the Chloride Conductivity values on the Cores from the piles and deck, all core specimens tested fall within the accepted range of less than 1 in Table 2. The minimum value is 0.15563 mS/cm and the maximum value is 0.225 mS/cm and the Acceptance Criteria (figure 33) for as-built structures is “Full acceptance”.
