***Report to Naidu Consulting (Pty) Ltd on the Results of a
Geotechnical Investigation for the Proposed Thandokuhle
Reservoir, eThekweni Municipality, KwaZulu-Natal***

Reference: 063-20.R01 Revision 1

Dated: 15 October 2020

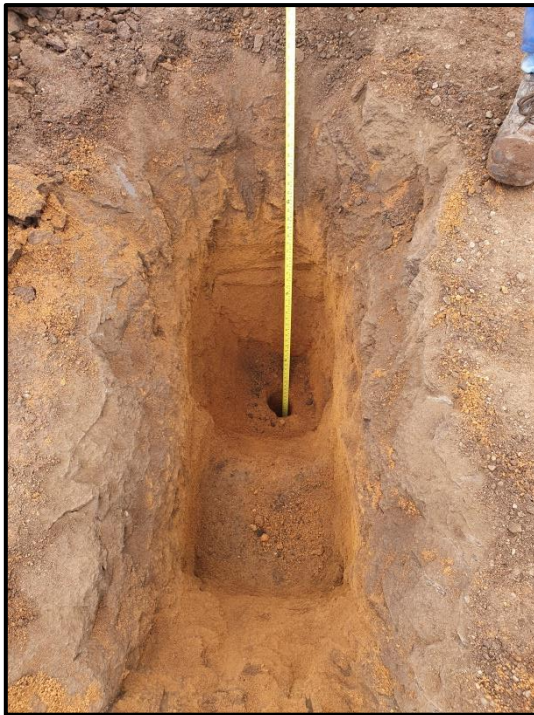
Plate 4: View of soil profile in IP1

Plates 4 and 5 show general ground profiles observed in the inspection pits during the field investigation. Detailed borehole core photographs are given in Appendix D.

The site was observed to be underlain by fill material, colluvium, residuals soils derived from the insitu weathering of the underlying Megacrystic granitic gneiss rock. These geological units are generally described in order of increasing depth.

Fill – The fill can be described as slightly moist, medium brown / light to dark greyish brown, loose to medium dense, fine to medium grained, silty SAND with an abundance of gravel to sandy silty GRAVEL / firm, slightly gravelly sandy CLAY. The fill was encountered in BH1 through BH4 and IP1 through IP9 was observed to extend to an depths in the approximate range 0.15m (IP3 and IP4 refer) to 0.63m (IP8 refers) below EGL.

Colluvium – Colluvium can be described as slightly moist to moist, medium brownish grey / dark grey / dark orange brown medium brownish grey / light greyish brown, firm to stiff, fine to medium grained, slightly gravelly sandy CLAY to sandy silty CLAY with occasional gravel. Colluvium was encountered in BH1, BH3 BH4, BH5 and IP5 through IP8 and was observed to extend to depths in the approximate range 0.35m (BH5 refers) to 1.52m (IP7 refers) below EGL.

Residual Gneiss – These soils can be described as slightly moist to moist, medium brownish orange / dark orange red / dark reddish orange / dark yellowish orange, firm to stiff, intact, slightly sandy clayey SILT / slightly gravelly silty CLAY / gravelly sandy CLAY / sandy silty CLAY / sandy CLAY. The residual soils were encountered in all the boreholes and inspection pits and were observed to extend to depths in the approximate range 0.88m (IP3 refers) to in excess of 9.45m (BH5) below EGL. The residual soils in

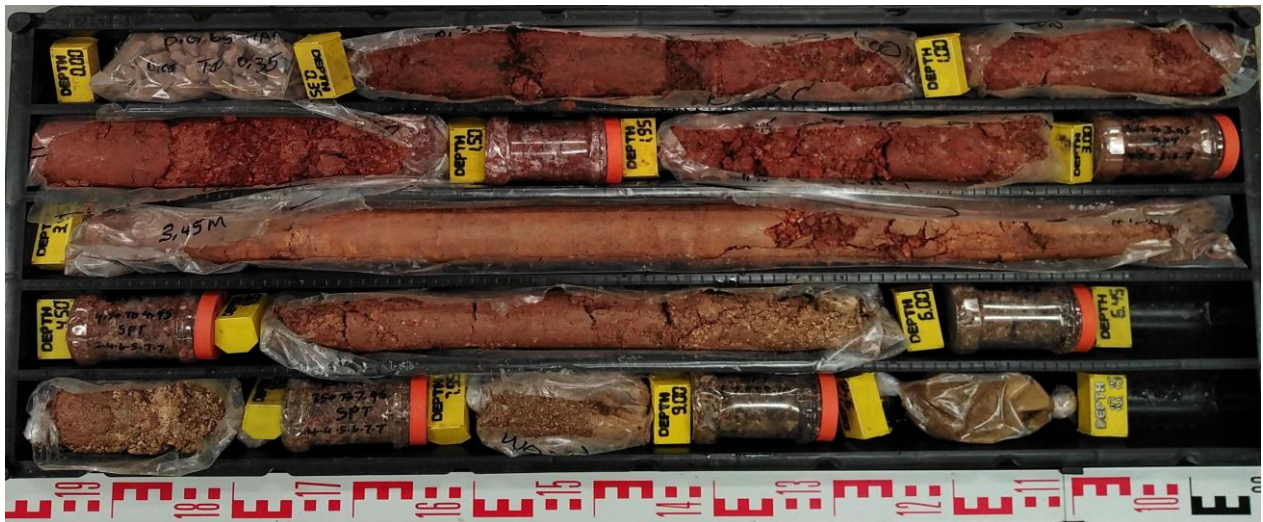
Client: Naidu Consulting (Pty) Ltd
Project: Proposed Thandokuhle Reservoir
Reference No.: 063-20
Borehole No: BH3
Depth: 0,00m to 10,22m
Box No: 1 of 1

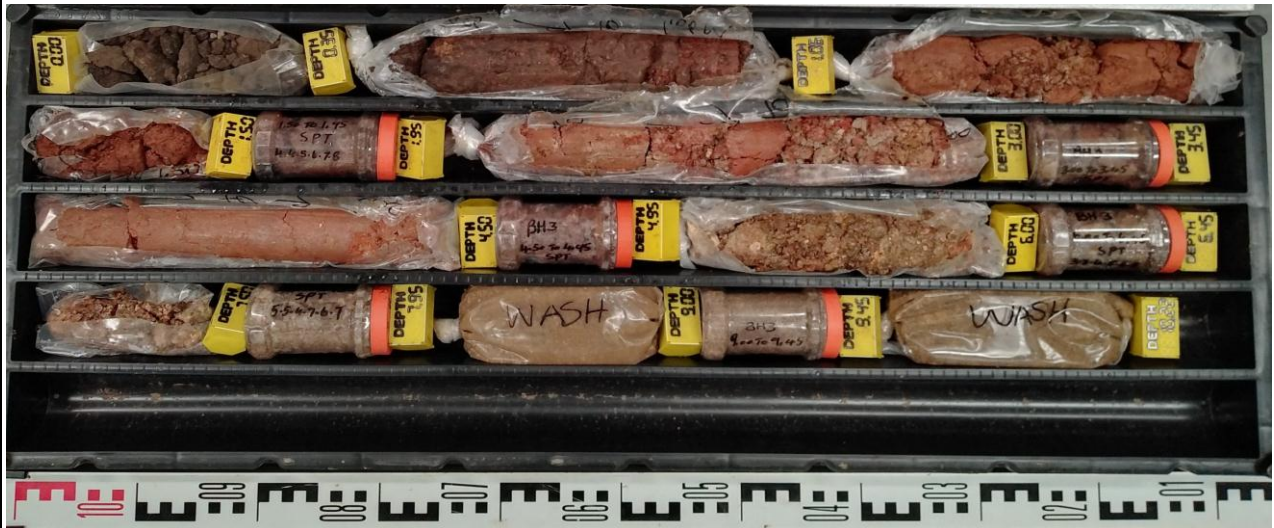
Client: Naidu Consulting (Pty) Ltd
Project: Proposed Thandokuhle Reservoir
Reference No.: 063-20
Borehole No: BH4
Depth: 0,00m to 10,0m
Box No: 1 of 1

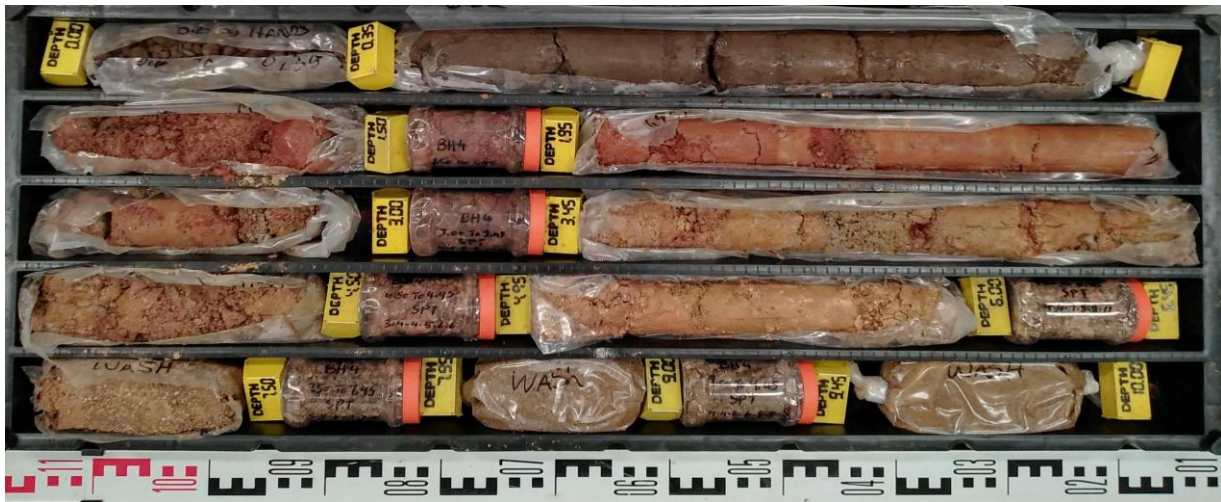
Client: Naidu Consulting (Pty) Ltd
Project: Proposed Thandokuhle Reservoir
Reference No.: 063-20
Borehole No: BH5
Depth: 0,00m to 9,45m
Box No: 1 and 2

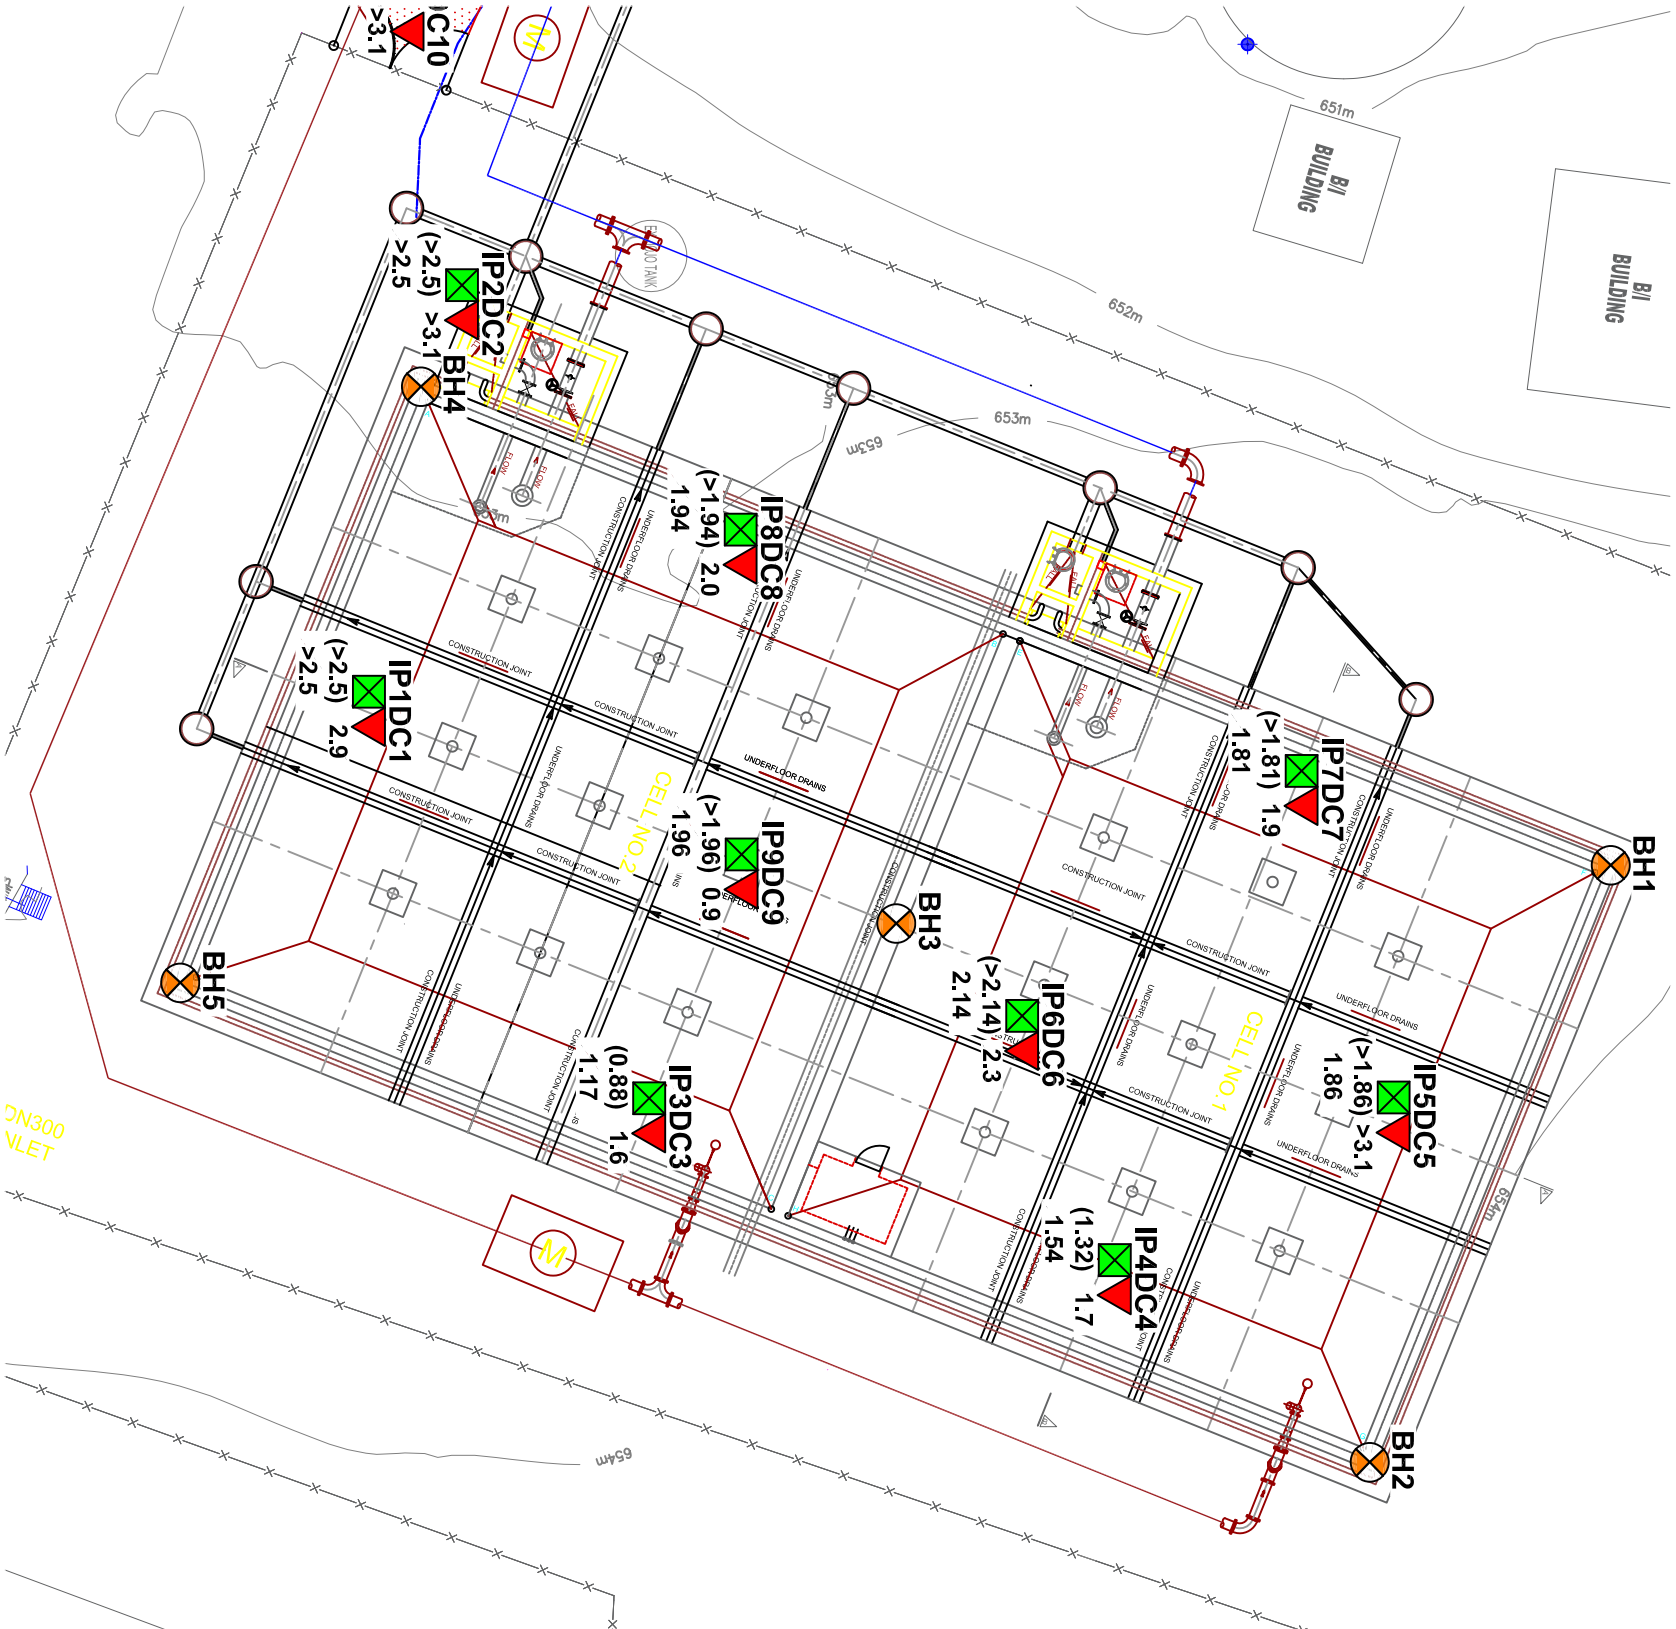
SITE PLAN

- BH1 Approximate position of Borehole.
- IP1 Approximate position of Inspection Pit showing depth to rock () and depth to refusal in metres below existing ground level.
- DC1 Approximate position of CBR Dynamic Cone Penetrometer Test showing depth to refusal in metres below existing ground level.

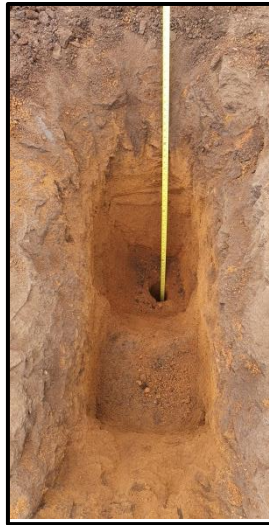
Plate 4: View of soil profile in IP1

Photographs showing the general soil profiles observed on site are given in Plates 4 through 7.
