ISLAND VIEW 4

QUAY SIDE INSPECTION

13 AUGUST 2018
DURBAN
SOUTH AFRICA

Island View 4
Quay Side Pile Inspection
13 August 2018 – 15 August 2018
SSD18-001B-032
Katlantic

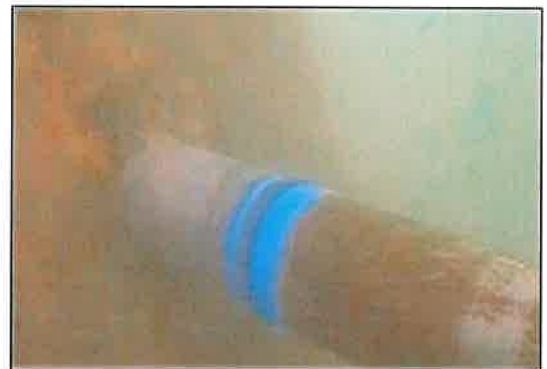
Core drilling at 5m depth

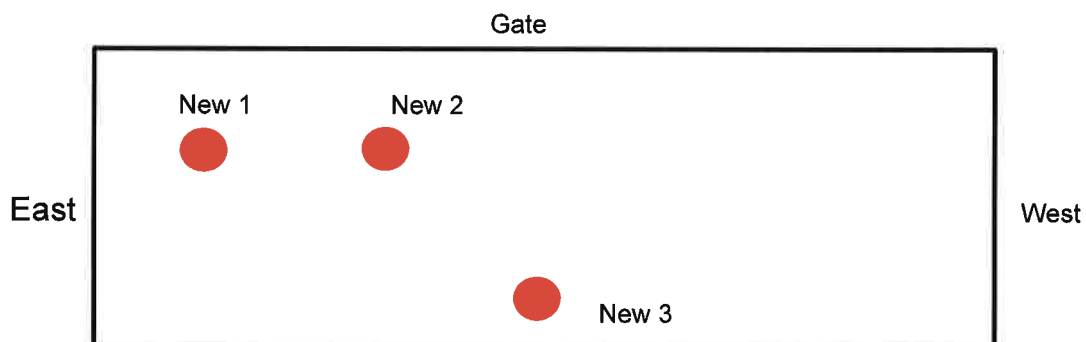
Deck slab core sample allocation

C-0.Sample taken at tidal
B-0.Sample taken at 5m depth in water
B-2.Sample taken at tidal
