CONTRACT NO.: TNPA 722

PROFESSIONAL SERVICES TO UNDERTAKE THE INSPECTION OF BERTH
4 OF ISLAND VIEW FOR THE PORT OF DURBAN

ENGINEERING REVIEW REPORT

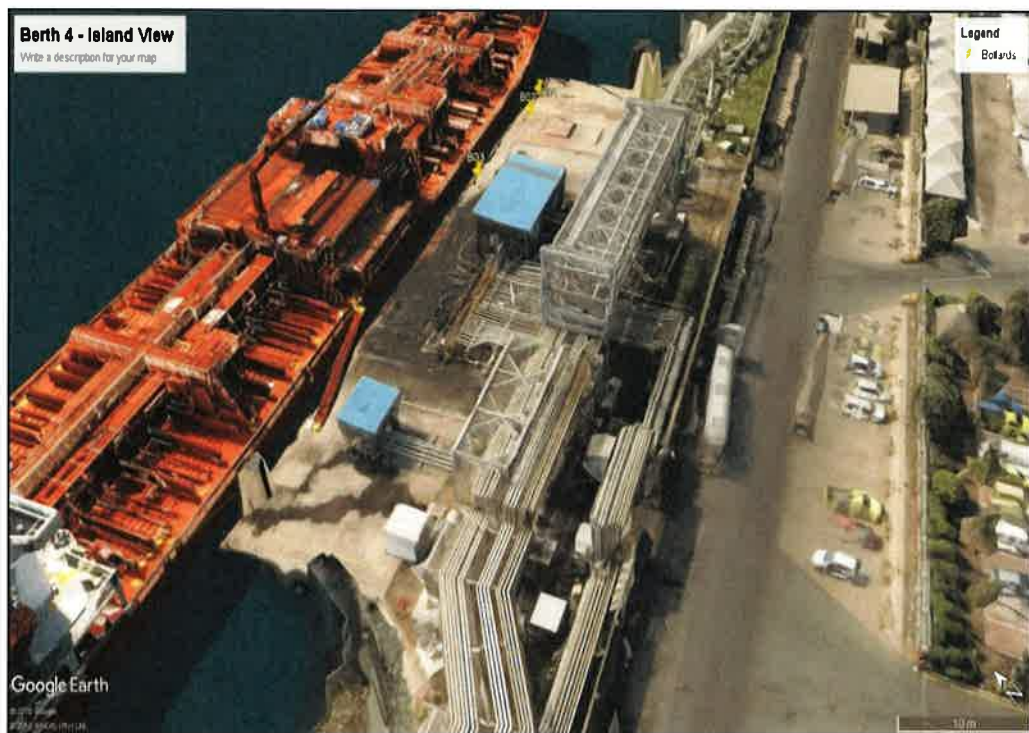
Figure 4: Berth 4 and surrounding infrastructure

A steel pipe rack is located to the south of the berth. This runs parallel to Wharfside Road. The revetment sea walls on either side of the berth consists of gabion walls that have overturned resulting in the hand stone being dislodged from the gabion baskets. A canopy structure houses a series of discharge manifolds supplying various chemicals to the ships docking at Berth 4. The structure is located more towards the western side of the concrete deck.

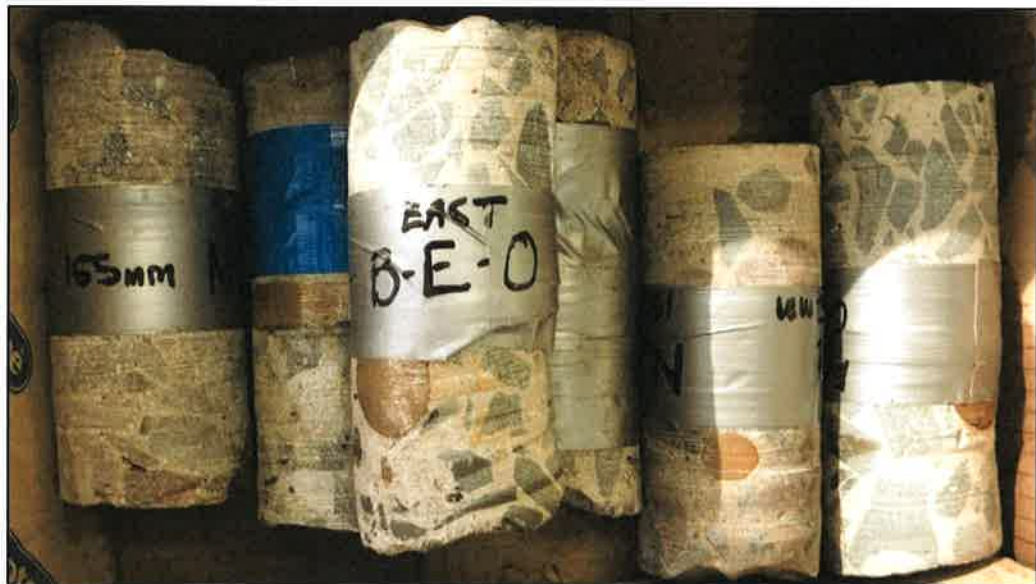
Figure 9: Concrete core samples retrieved from the berth's deck and piles

The test specimens considered in this method are circular discs prepared from the cores extracted from the deck at above water conditions and from the piles at underwater conditions. The cores for the upper deck were 90 mm in diameter by 300 mm in length. The cores retrieved from the piles were 70 mm in diameter by 152 mm in length. Figure 2 shows the cores retrieved from the site.

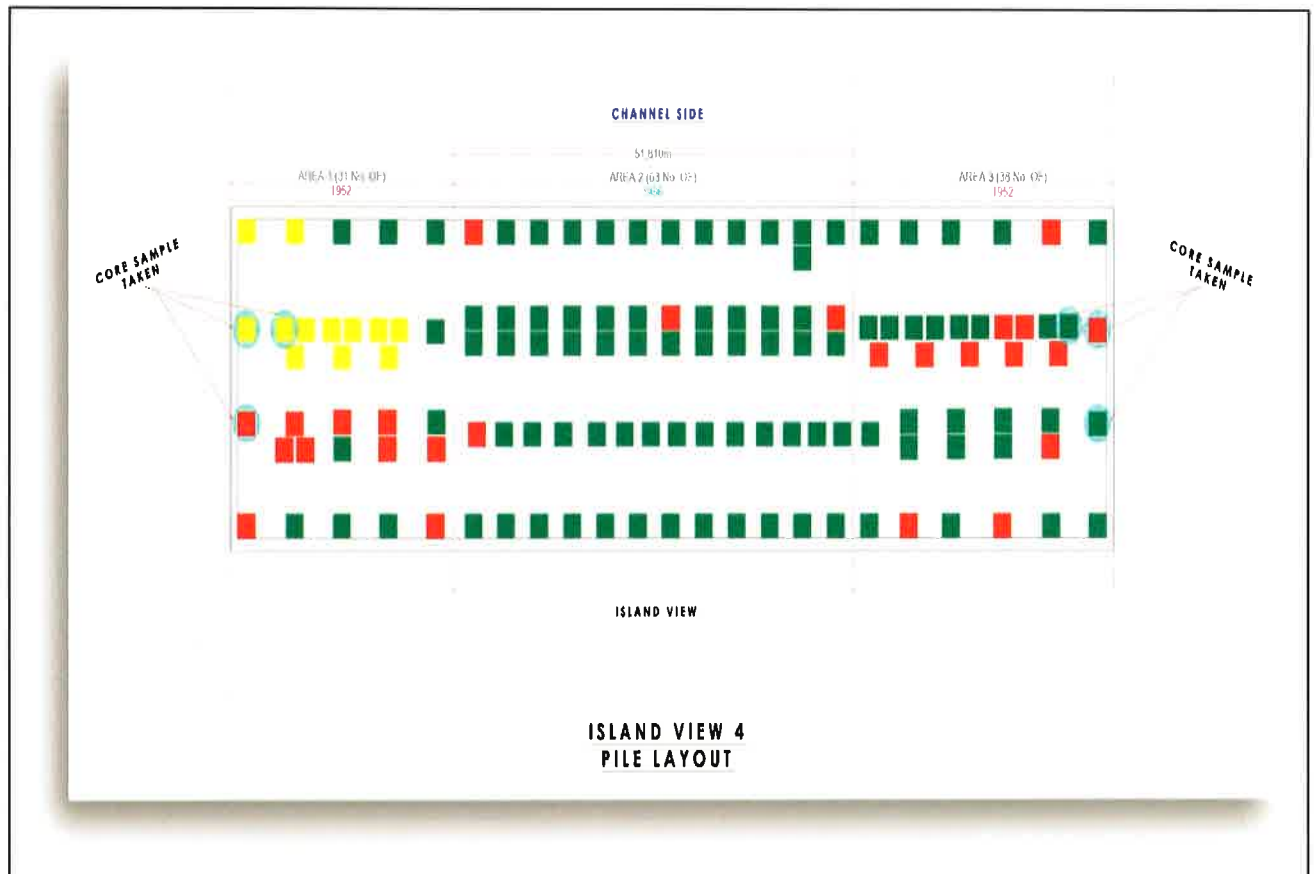
Figure 23: Plan view showing old and new portions of the berth as well as the precast pile inspected

Defects were noted on 6 of the 132 piles that were inspected. The cores for the piles have been selected as follows:

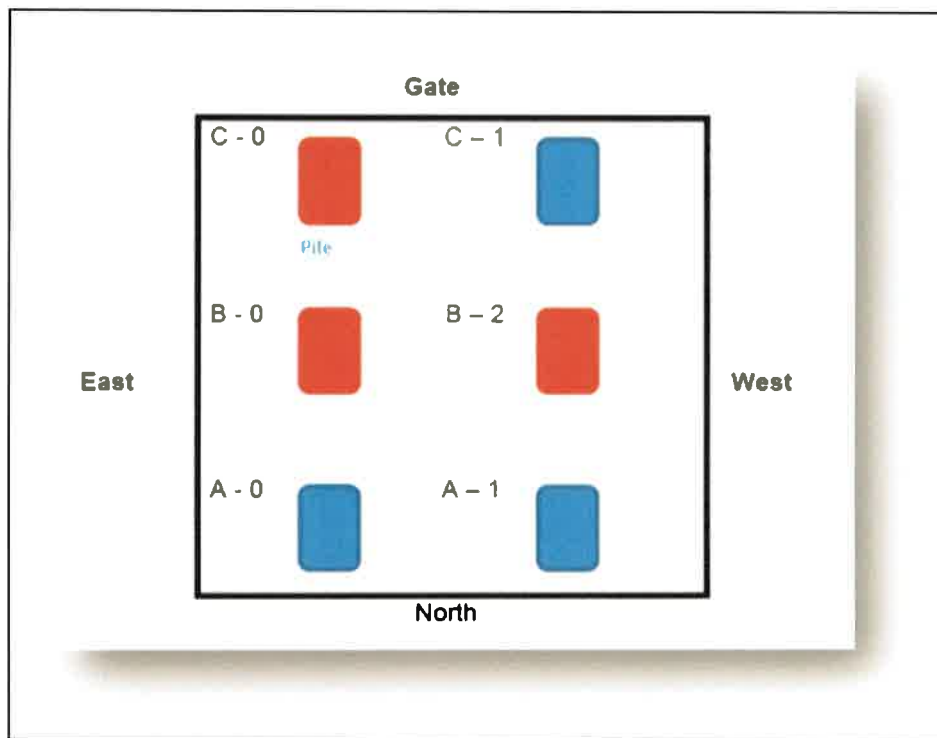
Figure 24: Positions of the cores taken from the precast piles

- On the East side (piles constructed in 1952)
- C-0 taken at tidal and facing North
- B-0 piles taken 5m below water surface
- B-2 – sample taken at tidal

All cores taken from piles were 75 mm in diameter and approximately 152 mm in height. These cores were tested for mechanical and chemical properties.
